SECTION 22
CONNECTICUT COASTAL STRUCTURES INVENTORY STUDY
PHASE II

APPENDIX J
BRANFORD QUADRANGLE

RECORDS OF STRUCTURES WITH PHOTOGRAPHS

JULY 1989

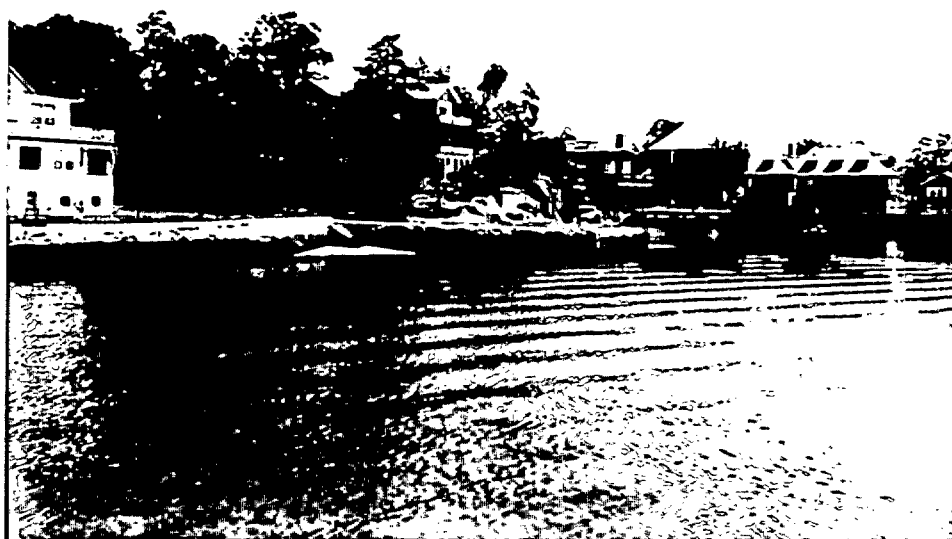
BR 2.00 #1

TYPE OF STRUCTURE: SEAWALL CONDITION: GOOD
MAIN FUNCTION : PREVENTS EROSION AND FLOODING
MATERIAL : STONE IN CEMENT

SEAWALL INTERRUPTED BY BEDROCK. SHORE COMPOSED OF EXPOSED
BEDROCK.

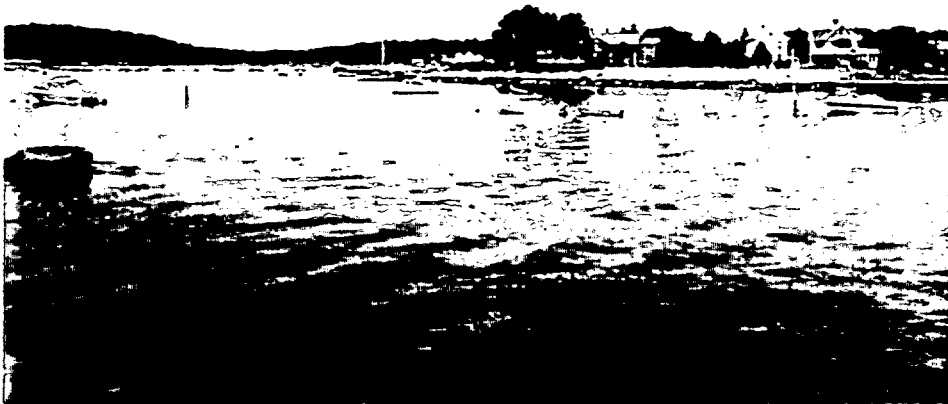
BR 3.00 #1

TYPE OF STRUCTURE: RIPRAP CONDITION: FAIR
MAIN FUNCTION : PROTECTIVE LAYER WHICH PREVENTS EROSION OF A SLOP
MATERIAL : LARGE BOULDERS

NO SHORE. AREA OF EXPOSED BEDROCK.

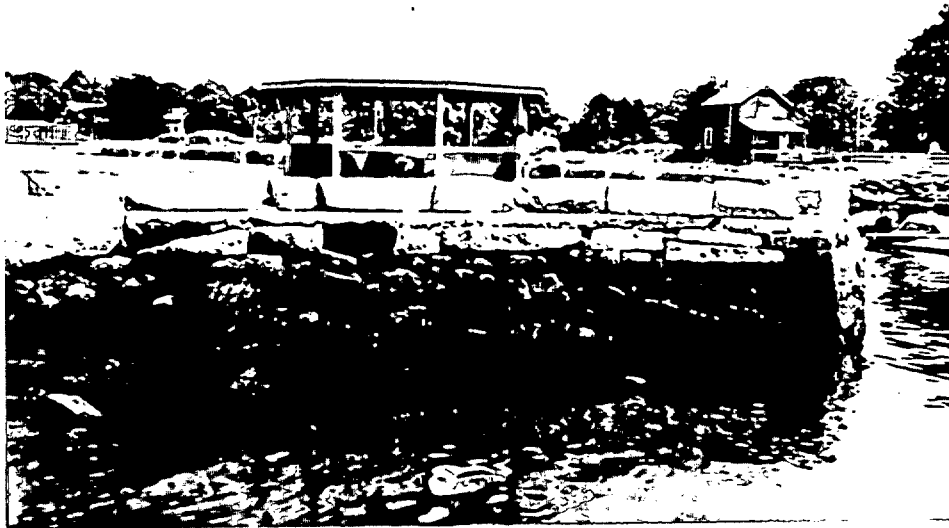
SR 4.00 #1

TYPE OF STRUCTURE: SEAWALL CONDITION: FAIR
MAIN FUNCTION : SEPARATES LAND AND WATER, PREVENTS EROSION
MATERIAL : STONE BLOCKS

NO SHORE. AREA OF EXPOSED BEDROCK.

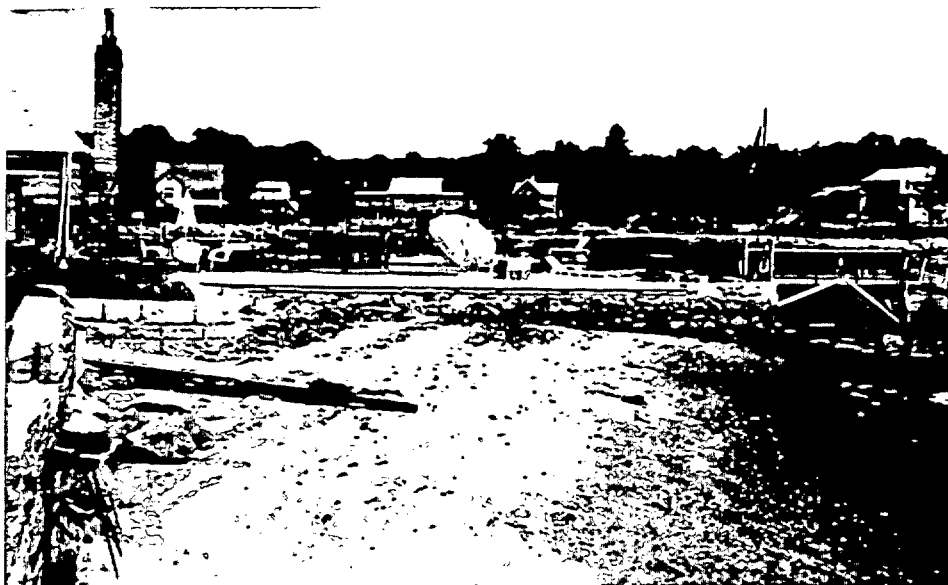
BR 6.00 #1

TYPE OF STRUCTURE: SEAWALL CONDITION: FAIR
MAIN FUNCTION : PREVENTS EROSION AND FLOODING
MATERIAL : STONE IN CEMENT

NO SHORE

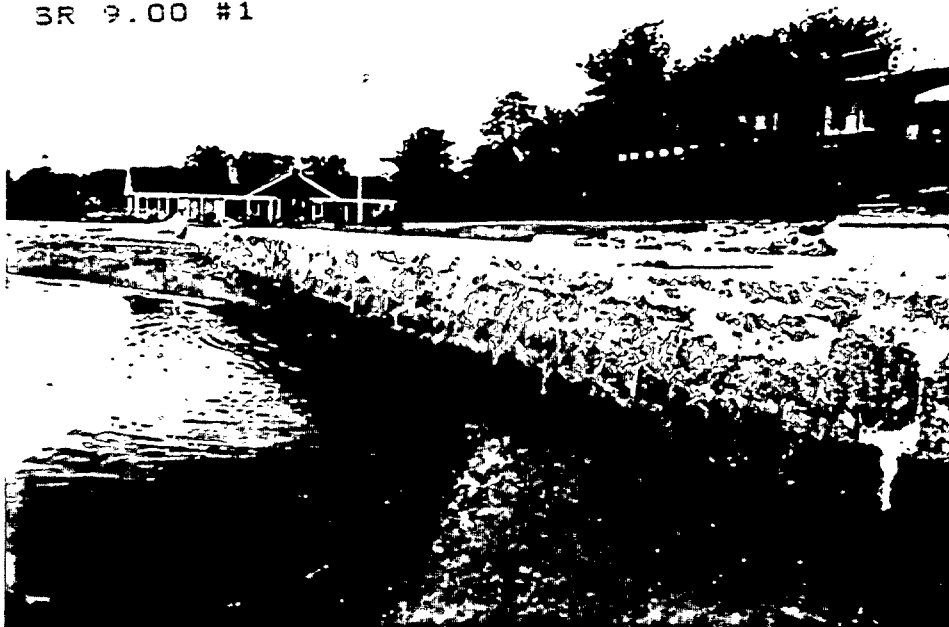
SR 9.00 #1

TYPE OF STRUCTURE: SEAWALL CONDITION: GOOD
MAIN FUNCTION : PREVENTS EROSION AND FLOODING
MATERIAL : STONE IN CEMENT

SHORE: SANDY BEACH BETWEEN GROINS. REBUILT SINCE HURRICANE GLORIA.

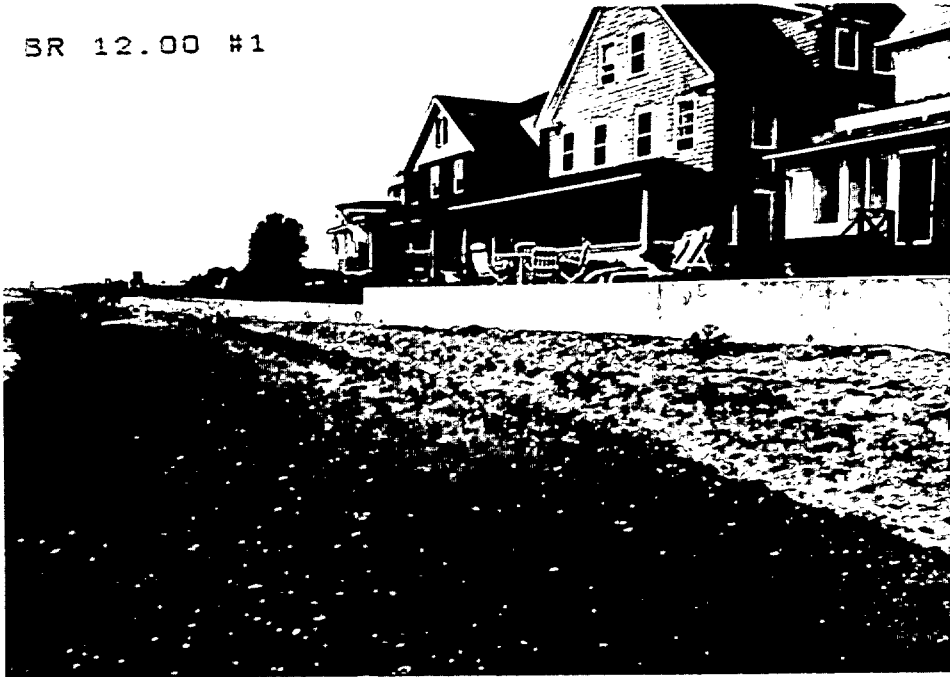
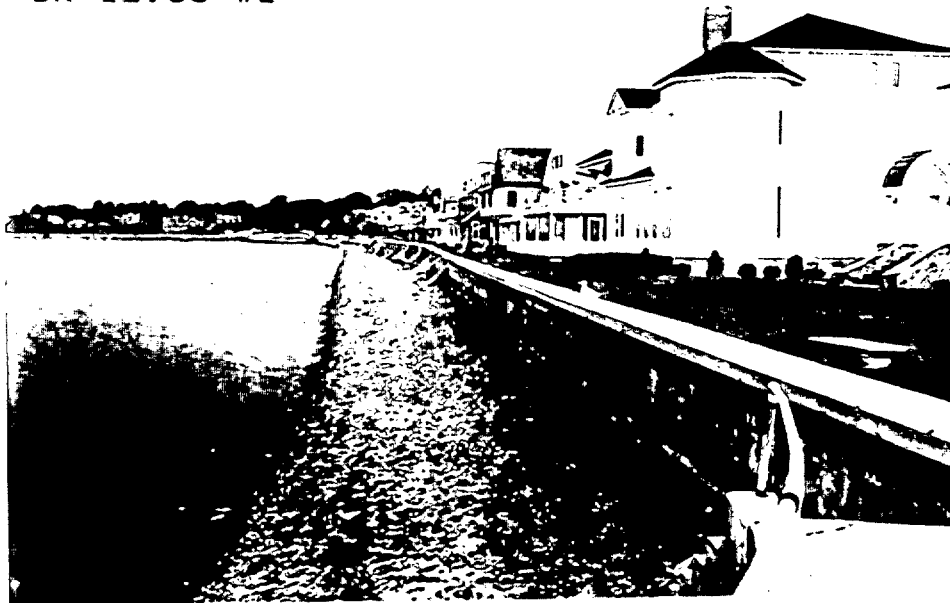
BR 12.00 #1

TYPE OF STRUCTURE: SEAWALL CONDITION: FAIR
MAIN FUNCTION : PREVENTS FLOODING
MATERIAL : STONE IN CEMENT

EXTENDS FROM BROWNS POINT. SAND SHORE WITH SMALL COBBLES.

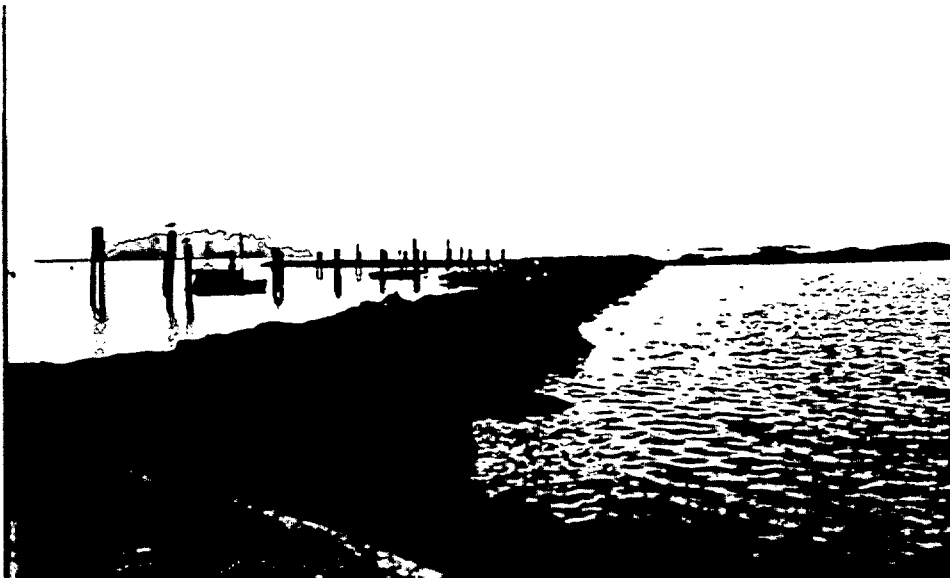
BR 13.00 #1

TYPE OF STRUCTURE: BREAKWATER CONDITION: GOOD
MAIN FUNCTION : PROTECTS HARBOR/ANCHORAGE BY INTERCEPTING WAVES
MATERIAL : STONE BLOCKS

SHORE: SANDY

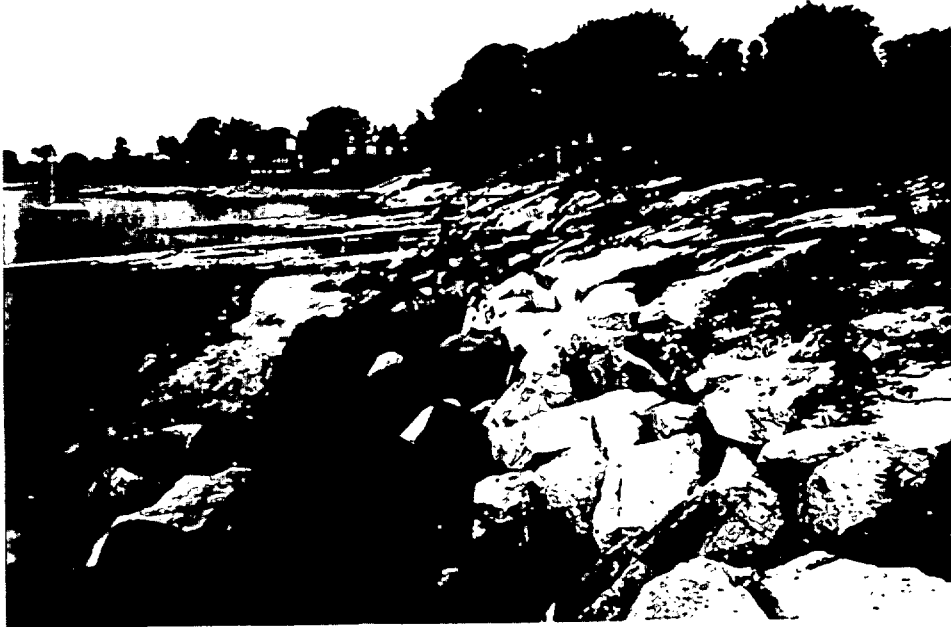
BR 15.00 #1

TYPE OF STRUCTURE: RIPRAP CONDITION: GOOD
MAIN FUNCTION : PROTECTIVE LAYER ON A SLOPE WHICH PREVENTS EROSION
MATERIAL : STONE BLOCKS

SHORE: SANDY WITH SMALL COBBLES

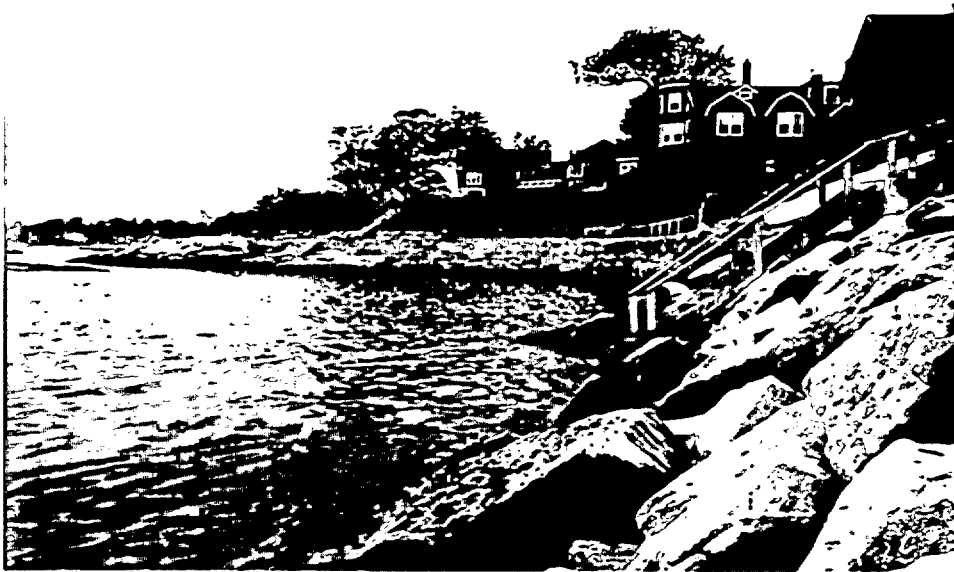
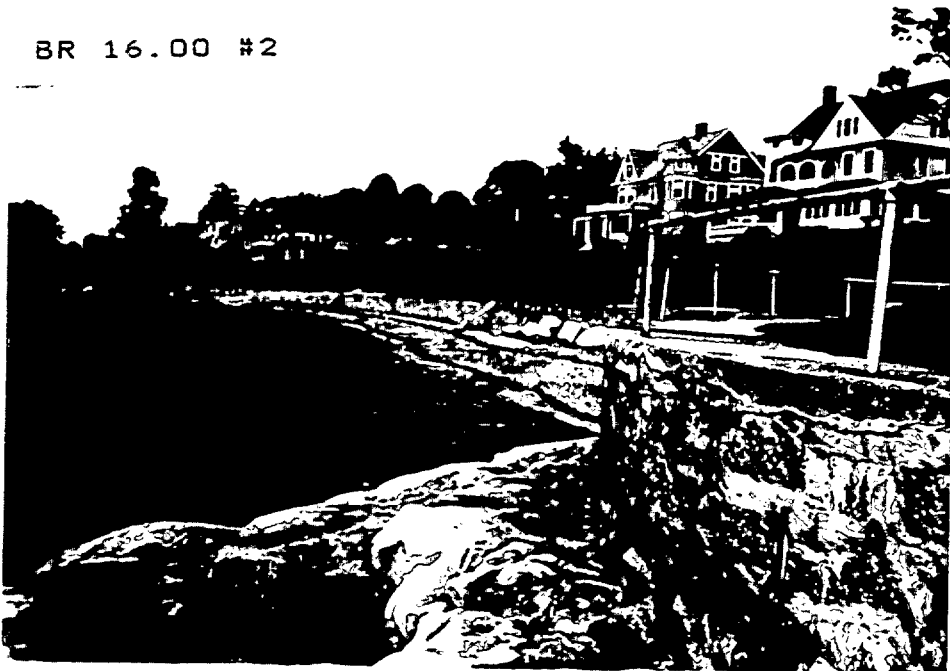
BR 16.00 #1

TYPE OF STRUCTURE: SEAWALL CONDITION: GOOD
MAIN FUNCTION : PREVENTS EROSION AND FLOODING
MATERIAL : STONE IN CEMENT

SHORE VARIES FROM NO SHORE TO EXPOSED BEDROCK TO SMALL
COBBLE BEACH.

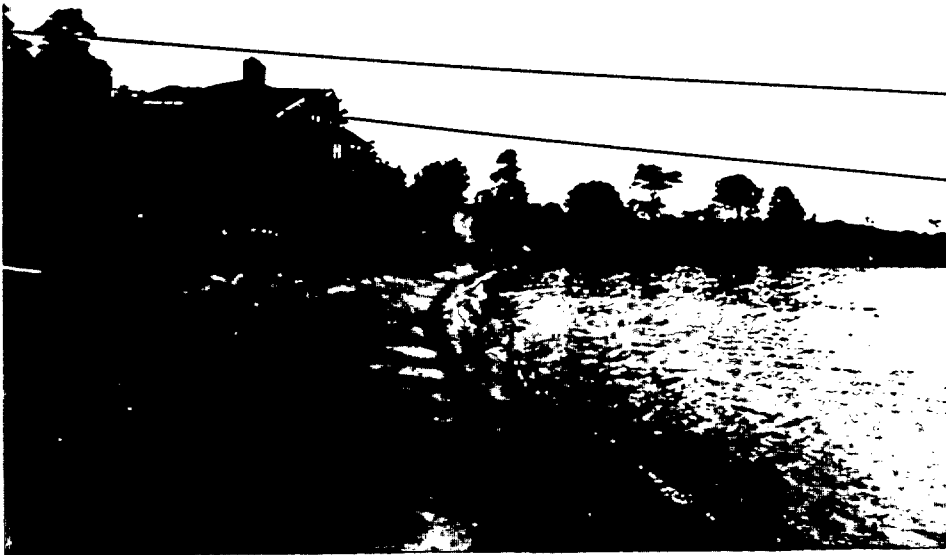
BR 17.00 #1

TYPE OF STRUCTURE: SEAWALL CONDITION: FAIR
MAIN FUNCTION : PREVENTS EROSION AND FLOODING
MATERIAL : STONE IN CEMENT

SHORE: SANDY

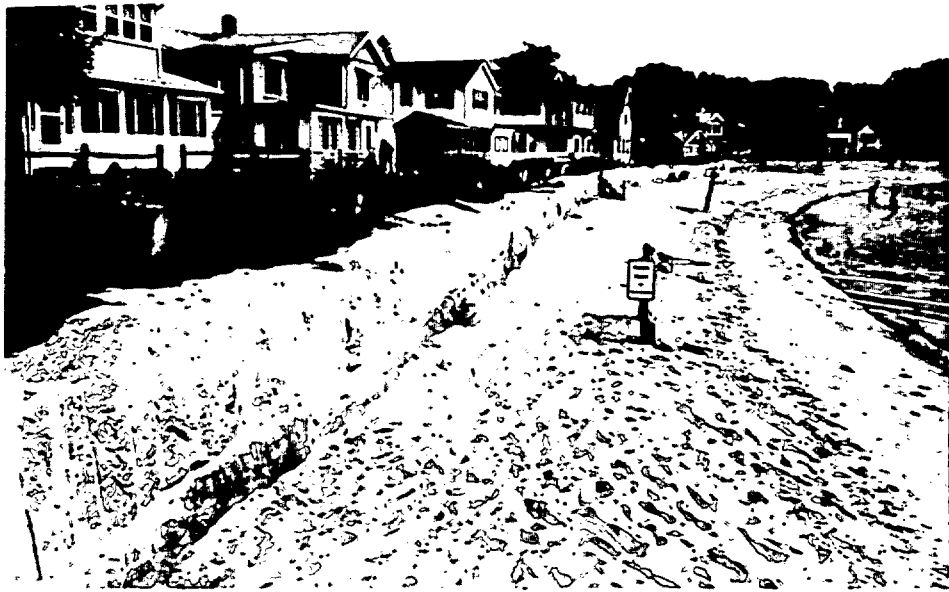
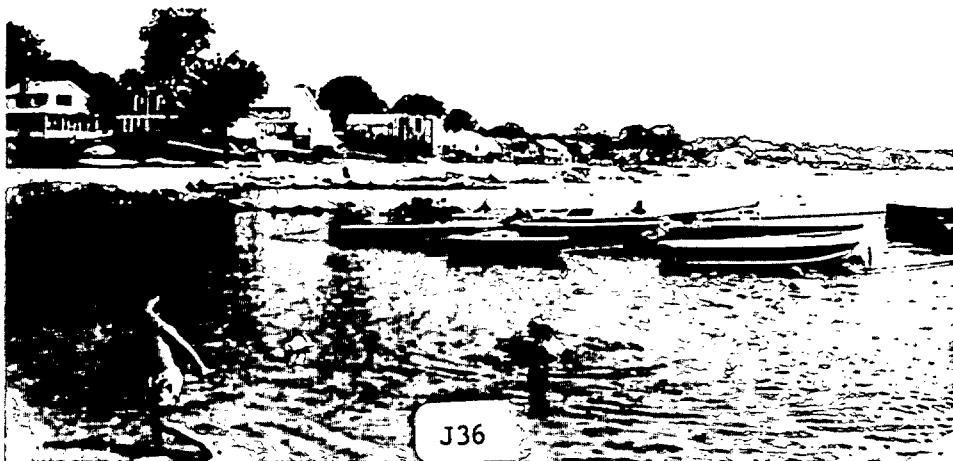
BR 18.00 #1

TYPE OF STRUCTURE: SEAWALL CONDITION: FAIR-POOR
MAIN FUNCTION : PREVENTS FLOODING AND EROSION
MATERIAL : STONE IN CEMENT

SHORE: VARIES. SANDY BEACH FOR RECREATION AT HOTCHKIS GROVE
BEACH. NO BEACH IN FRONT OF HOUSES.

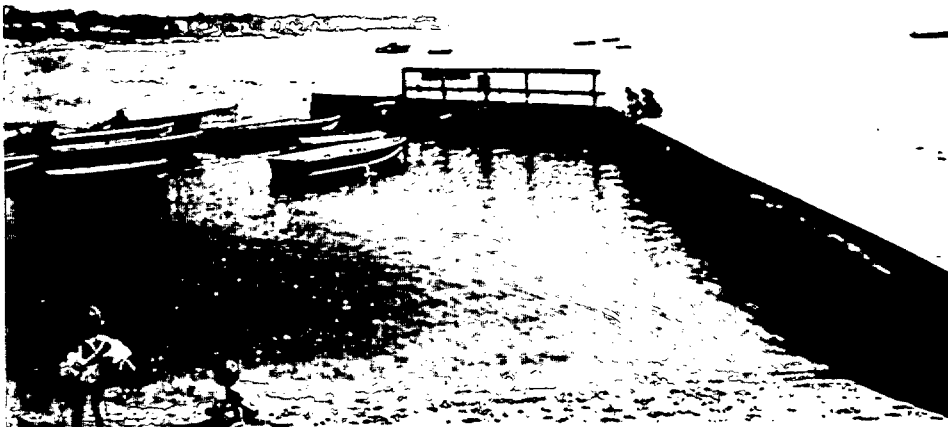
3R 19.00 #1

TYPE OF STRUCTURE: BREAKWATER CONDITION: GOOD
MAIN FUNCTION : PROTECTS ANCHORAGE BY INTERCEPTING WAVES
MATERIAL : STONE IN CEMENT

SHORE: SANDY BEACH. THEY BRING IN A TRUCK LOAD EACH YEAR.

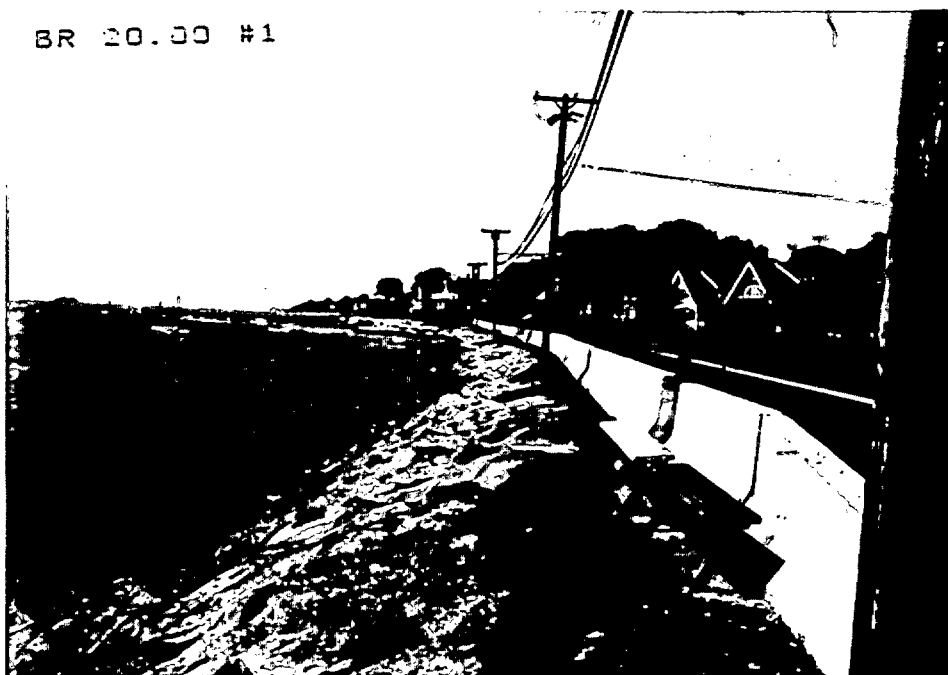
BR 20.00 #1

TYPE OF STRUCTURE: SEAWALL/REVTMNT CONDITION: FAIR
MAIN FUNCTION : PROTECTS SLOPE FROM EROSION
MATERIAL : STONE IN CEMENT

SHORE: SANDY SHORE AT LIMWOOD BEACH, BUT NO SHORE ALONG
REKETMENT.

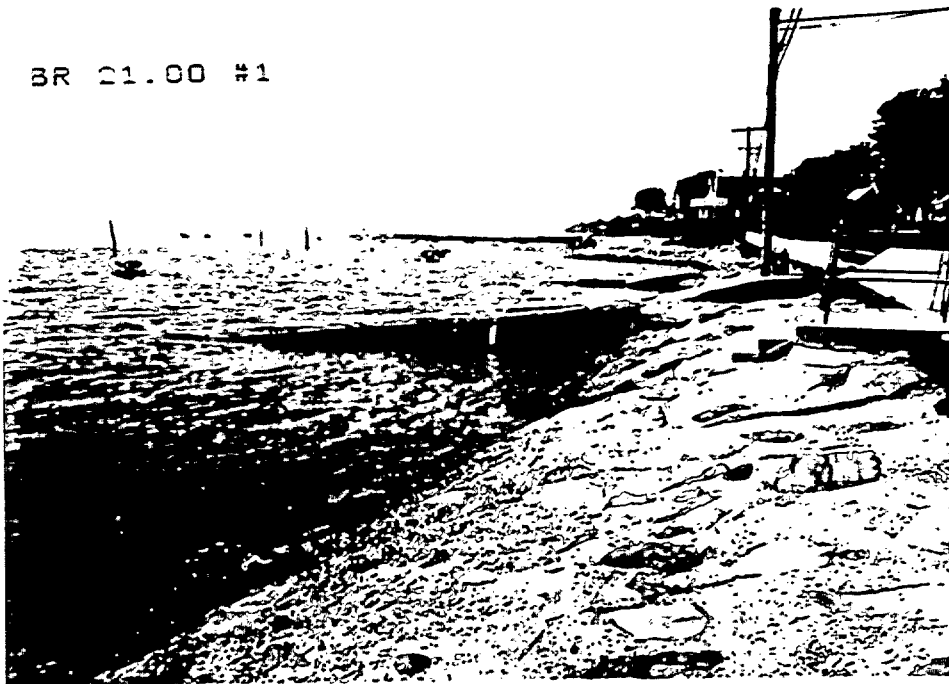
BR 21.00 #1

TYPE OF STRUCTURE: GROIN CONDITION: POOR
MAIN FUNCTION : TRAPS LITTORAL DRIFT
MATERIAL : TIMBER PILE

NO SHORE

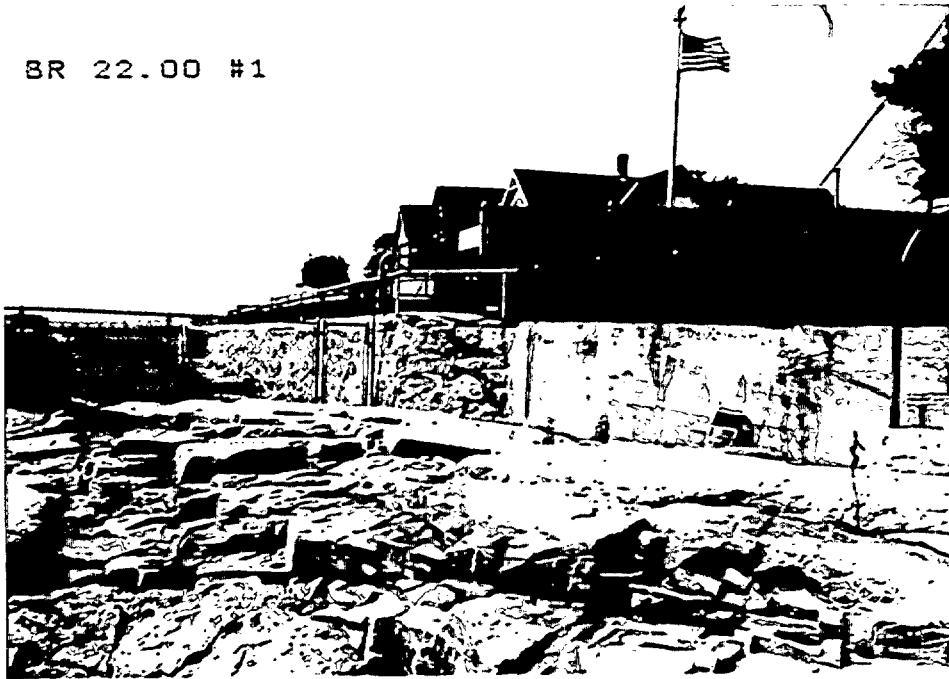
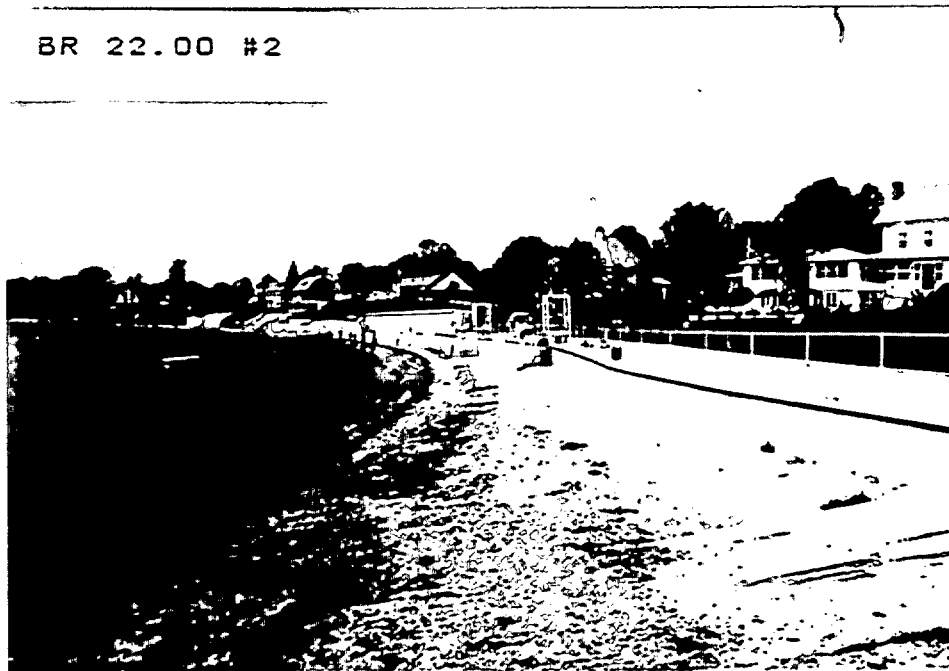
BR 22.00 #1

CONDITION: GOOD-POCR

SHORE: VARIES FROM EXPOSED BEDROCK TO SANDY BEACH

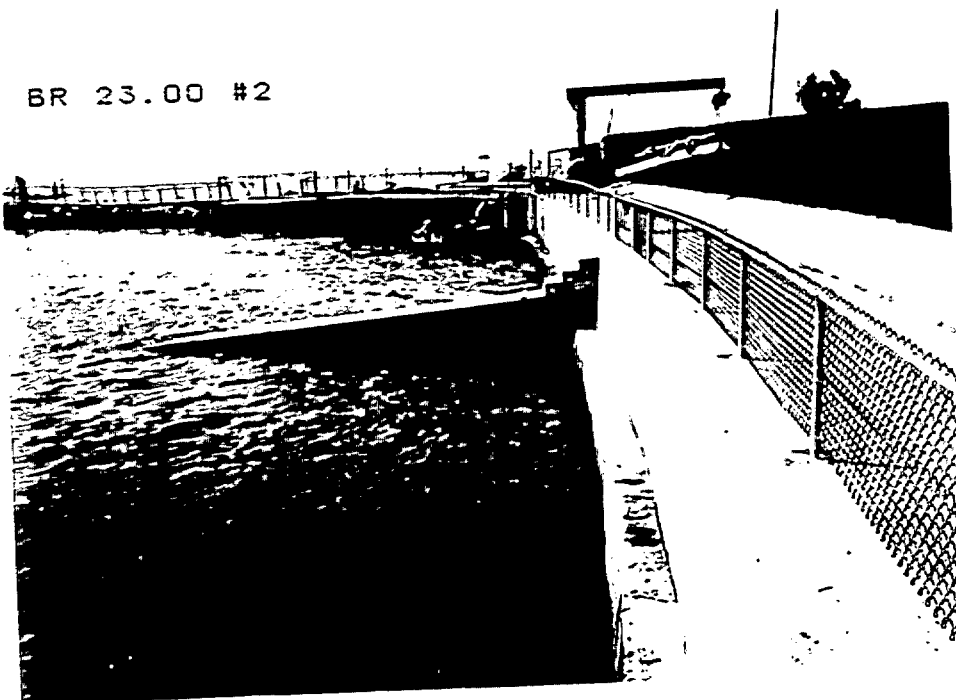
BR 23.00 #1

TYPE OF STRUCTURE: 2 GROINS CONDITION: FAIR
MAIN FUNCTION : TRAPS SAND, RETARDS SHORE EROSION
MATERIAL : WOOD

NO SHORE

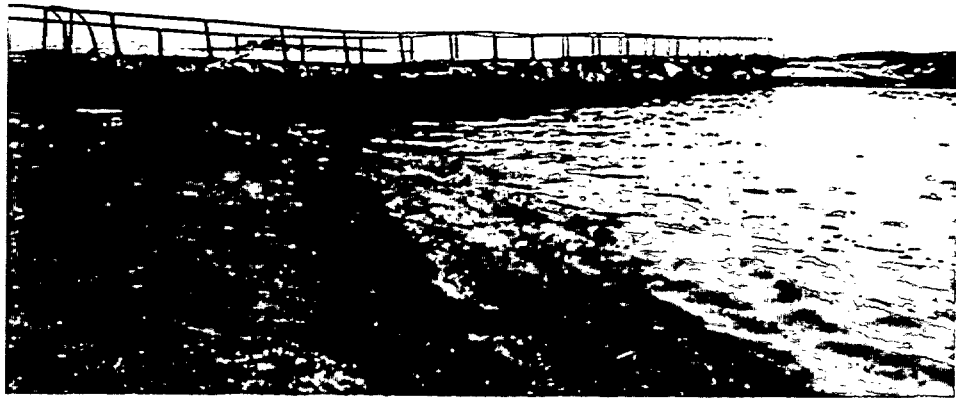
BR 24.00 #1

TYPE OF STRUCTURE: BREAKWATER CONDITION: POOR
MAIN FUNCTION : PROTECTS ANCHORAGE
MATERIAL : STONE BLOCKS

NO SHORE TO EAST. SANDY SHORE ON WEST IN FRONT OF OWENEGO
YACHT CLUB. SEAWALL IN FRONT OF YACHT CLUB NEW LAST YEAR.

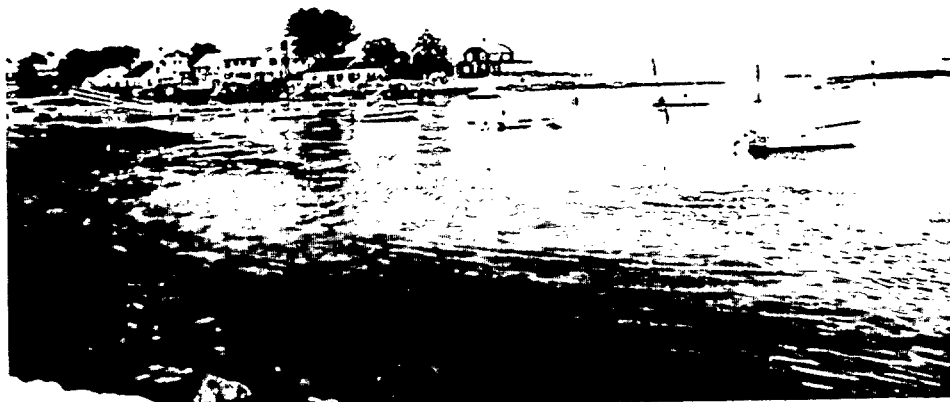
BR 28.00 #1

TYPE OF STRUCTURE: SEAWALL/BLKHEAD CONDITION: POOR
MAIN FUNCTION : RETAINS LAND, PREVENTS EROSION
MATERIAL : STONE IN CEMENT

NO SHORE

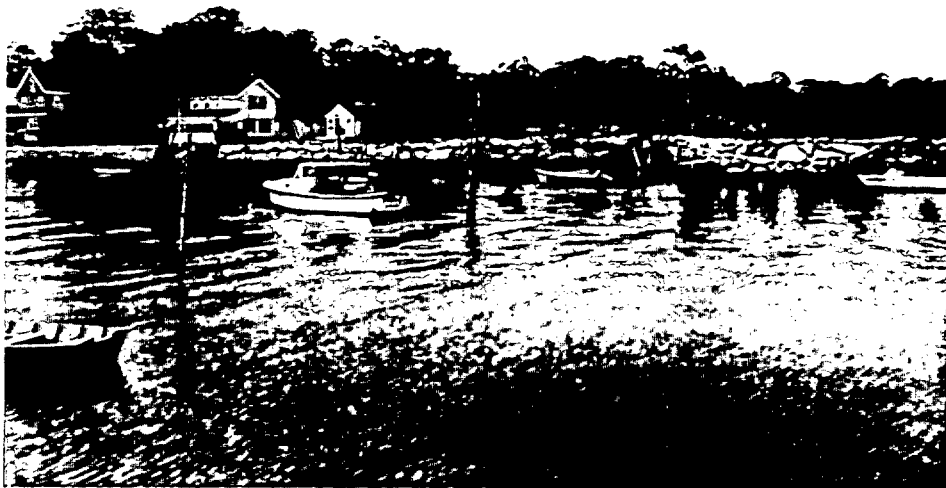
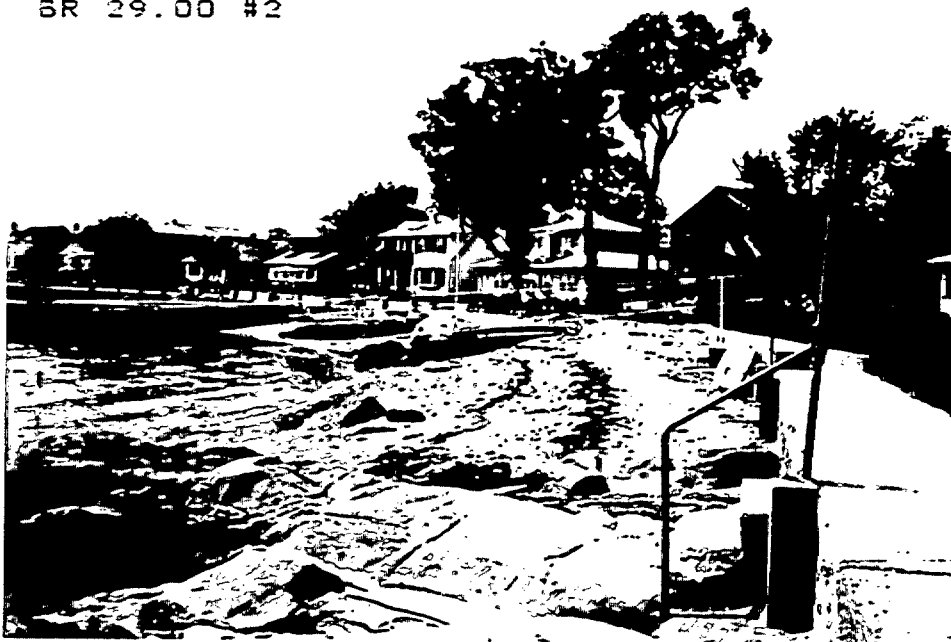
BR 29.00 #1

TYPE OF STRUCTURE: SEAWALL CONDITION: GOOD-FAIR
MAIN FUNCTION : PREVENTS EROSION AND FLOODING
MATERIAL : STONE IN CEMENT

NO SHORE IN FRONT OF SEAWALL ON EAST SIDE. ON WEST SIDE
SOME SANDY SHORE NEAR BREAKWATER. MARSHY AREA IN COVE.

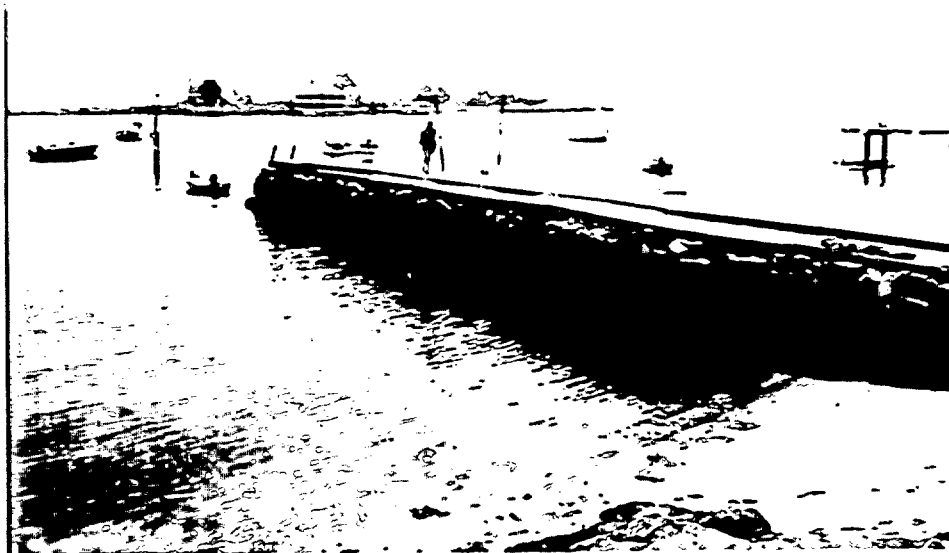
BR 30.00 #1

TYPE OF STRUCTURE: BREAKWATER CONDITION: GOOD
MAIN FUNCTION : PROTECTS ANCHORAGE
MATERIAL : STONE/CEMNT CAP

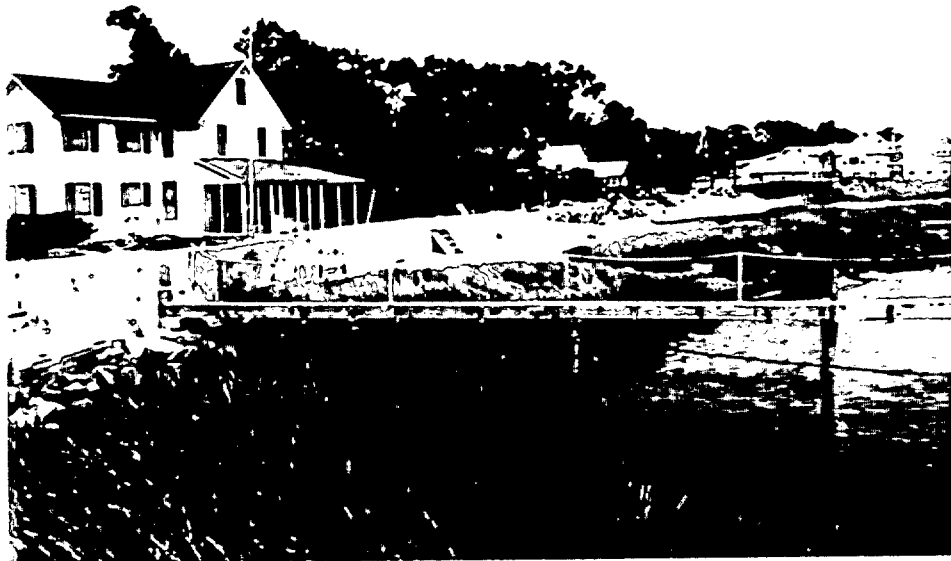
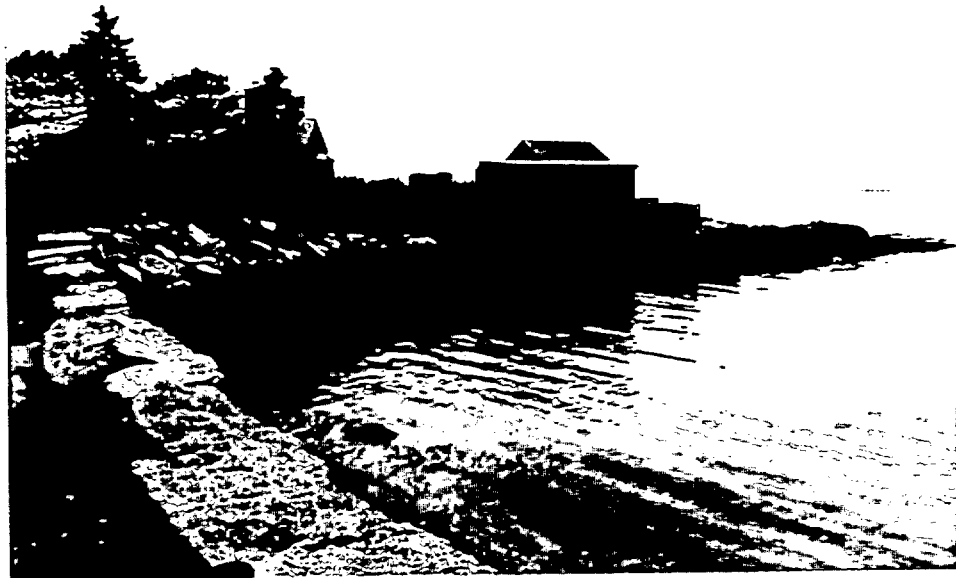
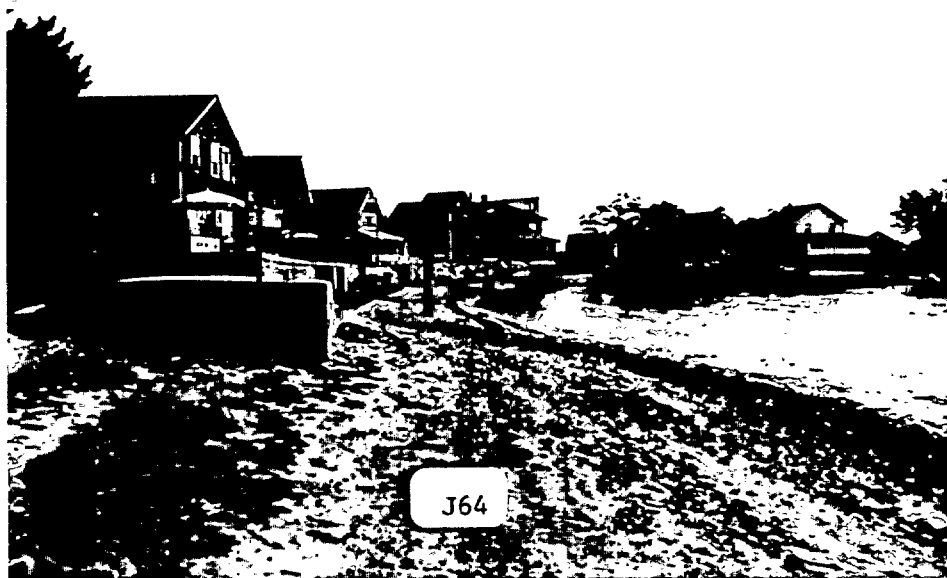
BR 32.00 #1

TYPE OF STRUCTURE: SEAWALL CONDITION: FAIR
MAIN FUNCTION : PREVENTS EROSION
MATERIAL : STONE IN CEMENT

EXPOSED BEDROCK AND MARSHY AREAS

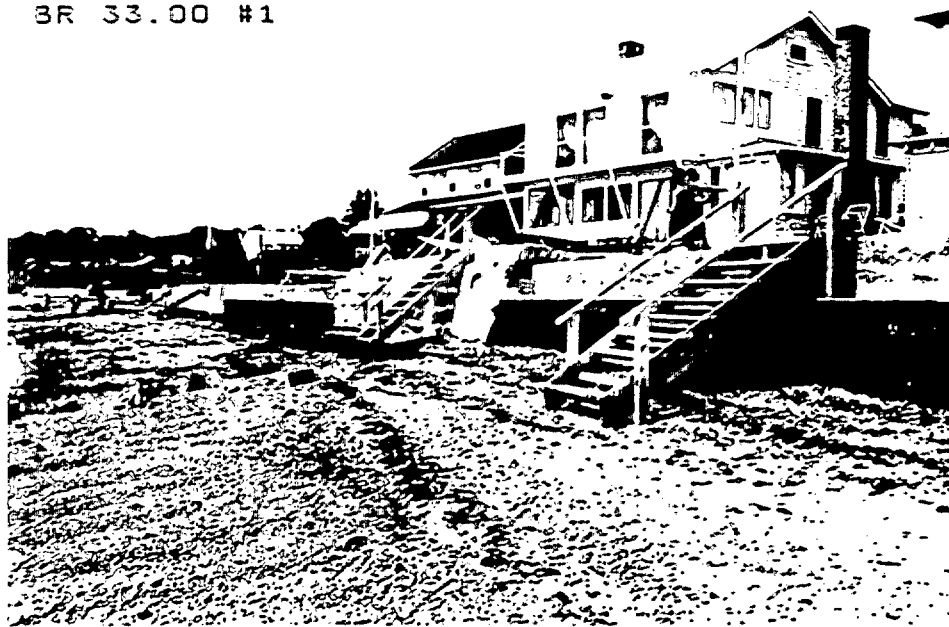
BR 33.00 #1

TYPE OF STRUCTURE: SEAWALL CONDITION: FAIR
MAIN FUNCTION : PREVENTS EROSION AND FLOODING
MATERIAL : STONE IN CEMENT

SHORE: SANDY WITH SMALL COBBLES

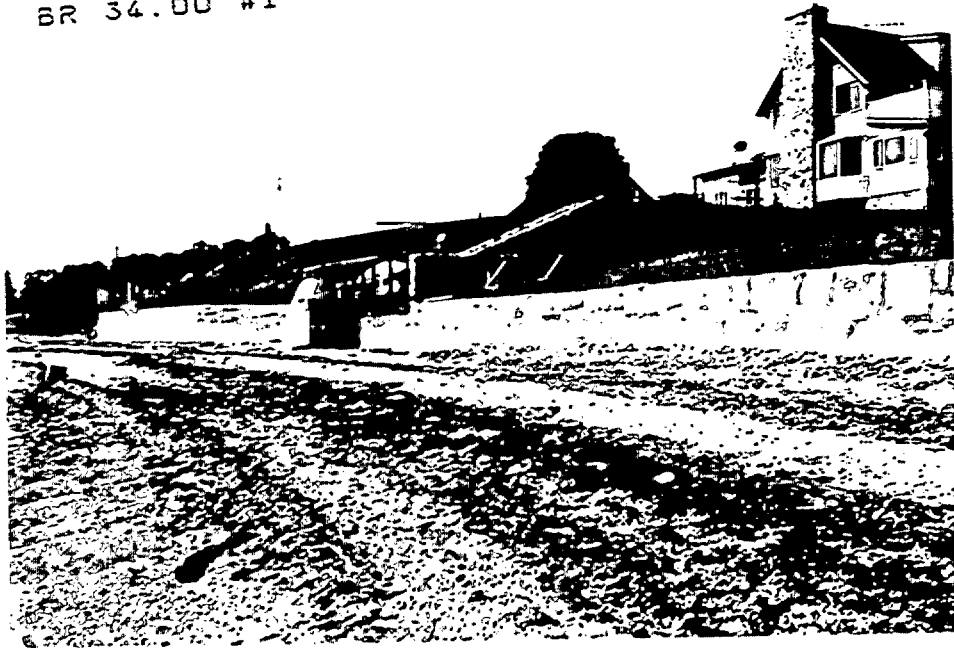
BR 34.00 #1

TYPE OF STRUCTURE: BULKHEAD CONDITION: FAIR
MAIN FUNCTION : RETAINS LAND, PREVENTS EROSION
MATERIAL : STONE IN CEMENT

SHORE: SANDY WITH SMALL PEBBLES

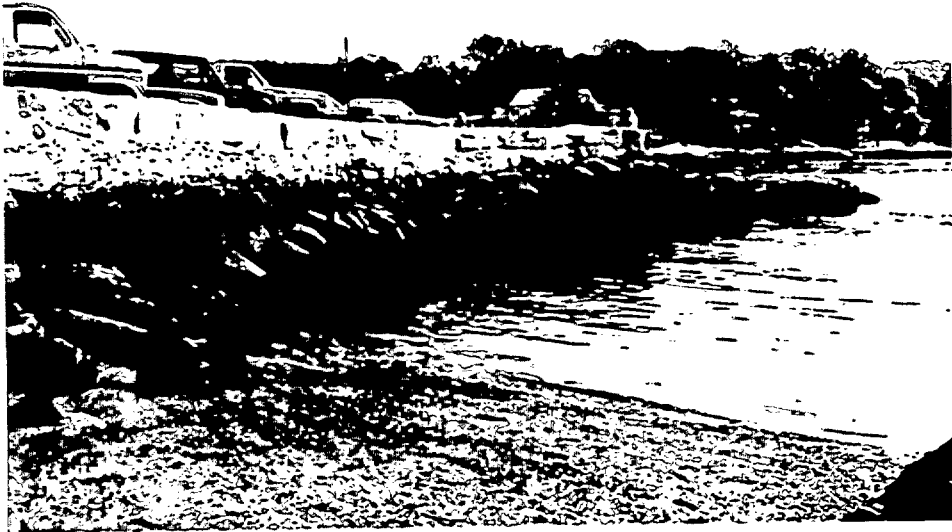
BR 35.00 #1

TYPE OF STRUCTURE: JETTY CONDITION: GOOD
MAIN FUNCTION : PROTECTS ANCHORAGE BY INTERCEPTING WAVES
MATERIAL : STONE BLOCKS

PROTECTS HARBOR IN BRANFORD RIVER

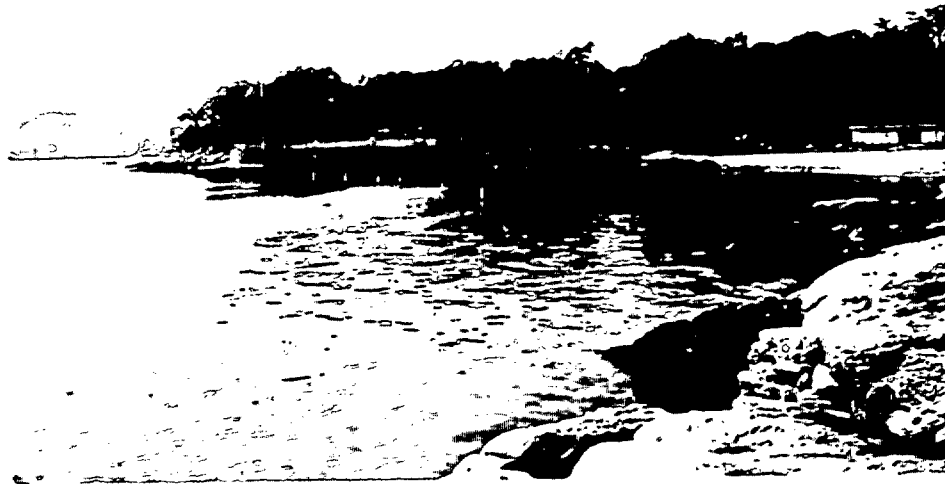
BR 36.00 #1

TYPE OF STRUCTURE: SEAWALL CONDITION: GOOD
MAIN FUNCTION : PREVENTS EROSION AND SLIDING OF BANK
MATERIAL : STONE IN CEMENT

SHORE: SANDY BEACH

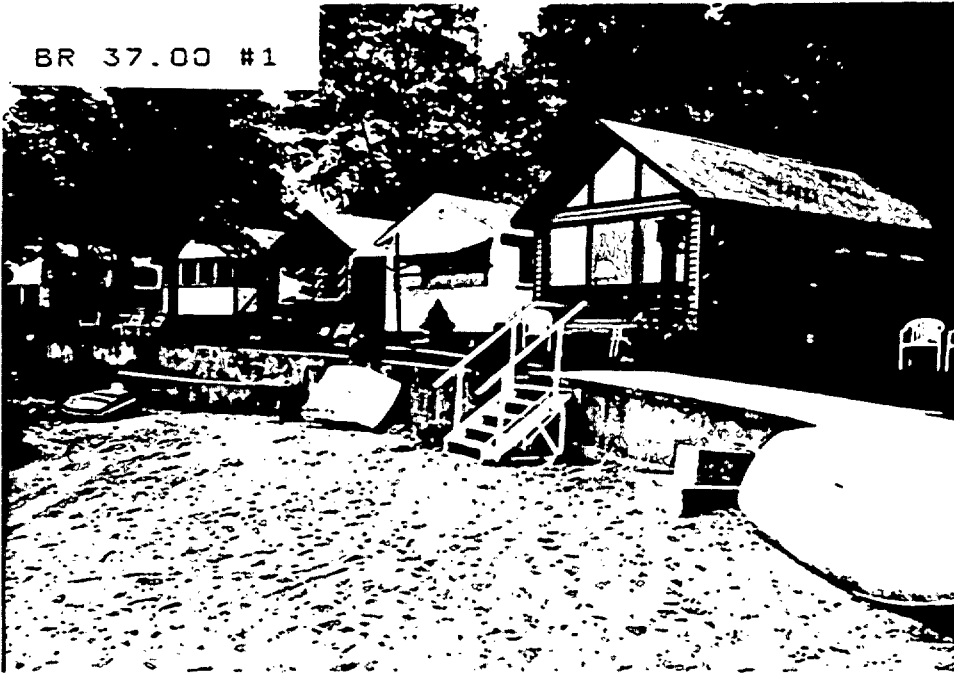
BR 37.00 #1

TYPE OF STRUCTURE: SEAWALL CONDITION: POOR
MAIN FUNCTION : PREVENTS FLOODING, RETAINS LAND
MATERIAL : CONCRETE

SANDY COVE

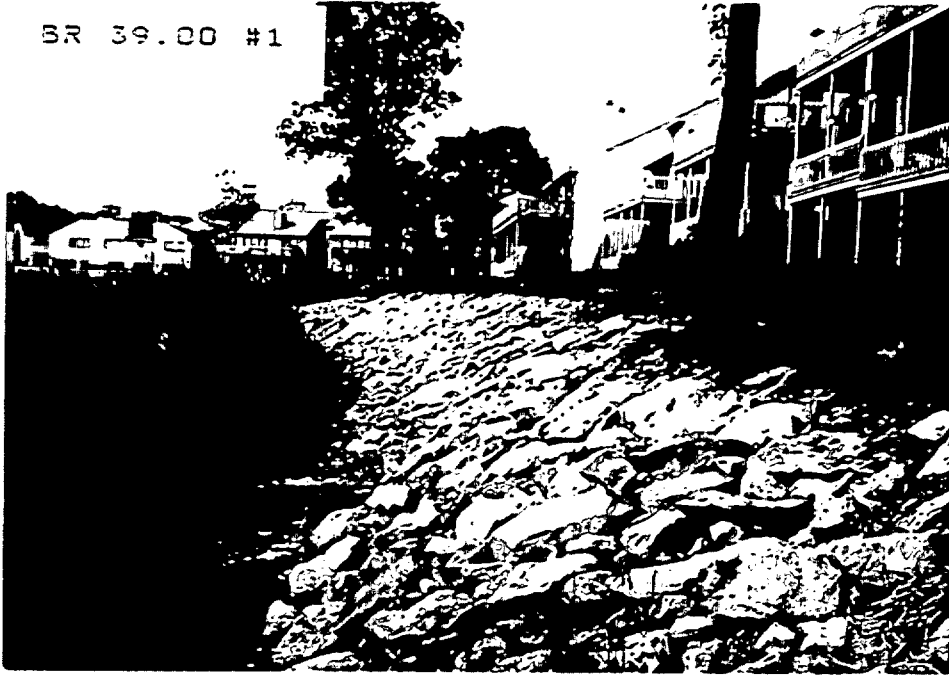
BR 39.00 #1

TYPE OF STRUCTURE: REVETMENT CONDITION: GOOD
MAIN FUNCTION : FACING ON SLOPE WHICH PREVENTS EROSION
MATERIAL : IRR. STONE FRAG

MARSHY SHORE

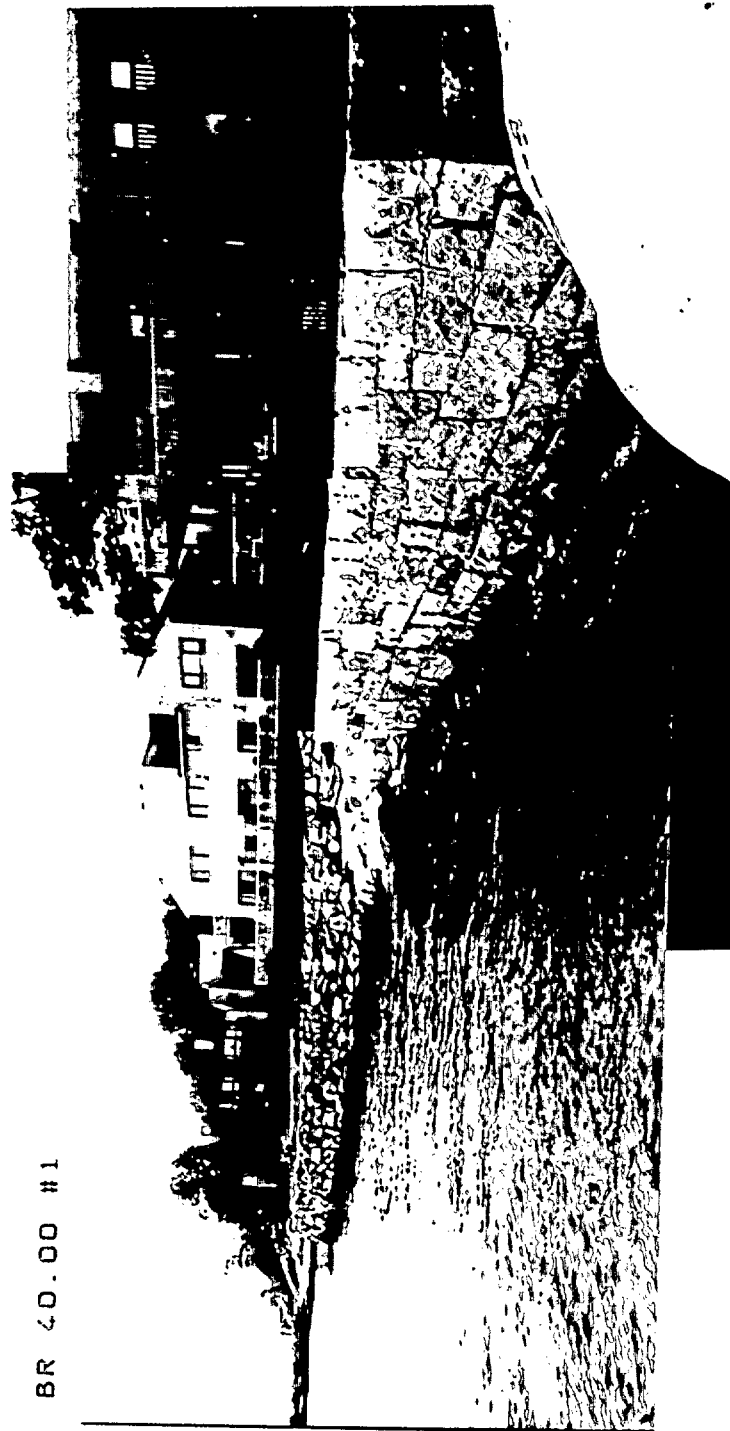
BR 40.00 #1

TYPE OF STRUCTURE: SEAWALL CONDITION: GOOD
MAIN FUNCTION : PREVENTS EROSION
MATERIAL : STONE BLOCKS

NO SHORE

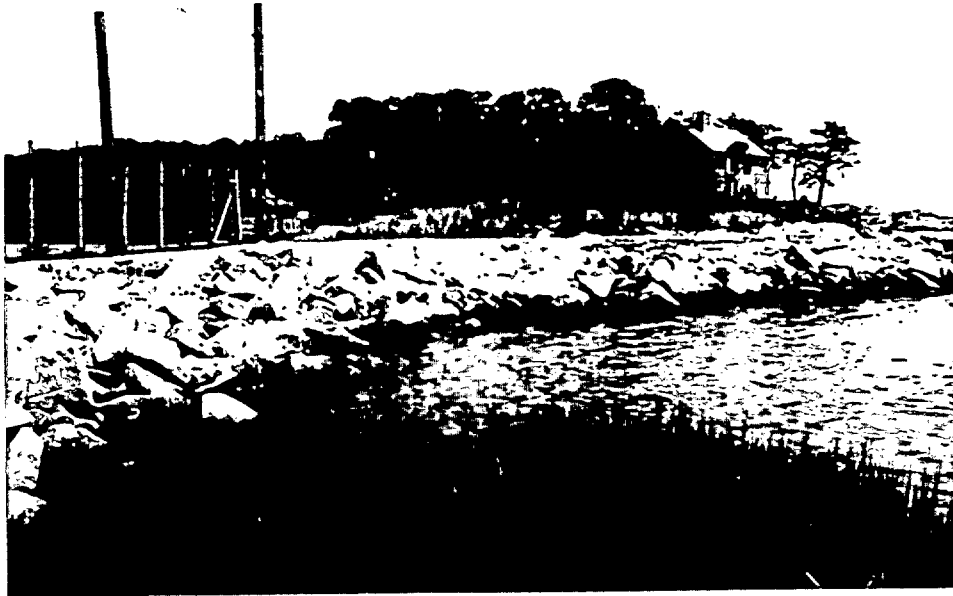
BR 42.00 #1

TYPE OF STRUCTURE: SEAWALL CONDITION: FAIR
MAIN FUNCTION : PREVENTS EROSION
MATERIAL : STONE IN CEMENT

SHORE: EXPOSED BEDROCK

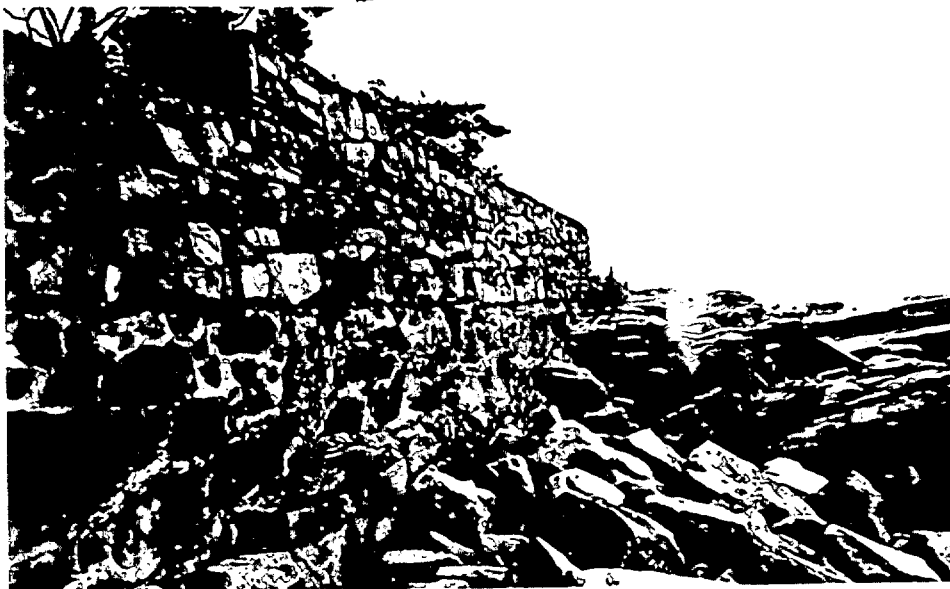
BR 43.00 #1

TYPE OF STRUCTURE: SEAWALL CONDITION: GOOD
MAIN FUNCTION : RETAINS LAND, PREVENTS EROSION
MATERIAL : STONE IN CEMENT

SHORE: EXPOSED BEDROCK WITH SOME MARSHY AREAS.

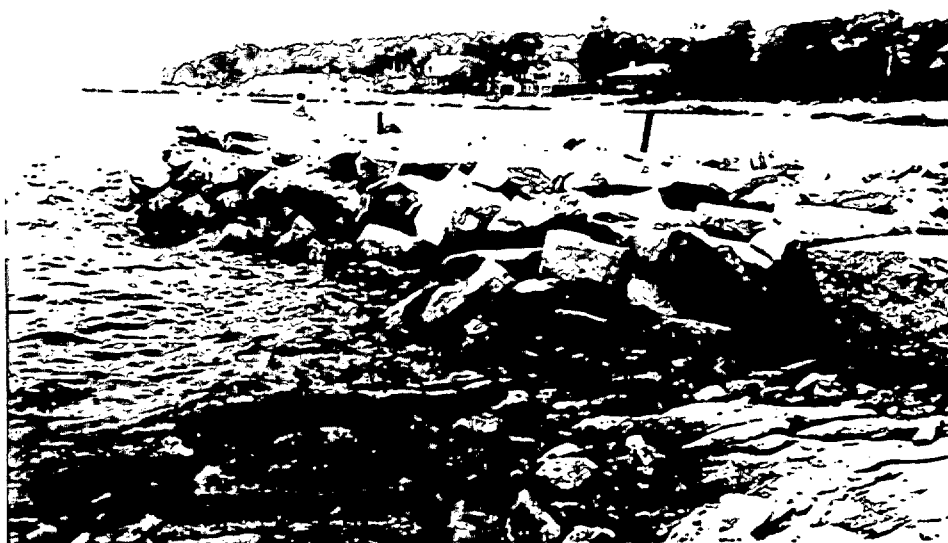
ER 45.00 #1

TYPE OF STRUCTURE: BREAKWATER CONDITION: GOOD
MAIN FUNCTION : PROTECTS HARBOR/ANCHORAGE
MATERIAL : STONE BLOCKS

SHORE: EXPOSED BEDROCK
